## Crowd Wowed by Zoch and Dutch Barn

*Jackie Turnquist*

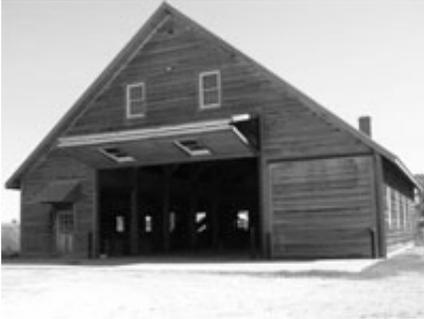
Exterior of the replica Dutch Barn at Argus Acres.

As people arrived, they had time prior to the presentation to explore the 3 story building completed in 1993 by David Graulich. Although it is a working barn, one would be hard-pressed to find a similarly well-maintained building anywhere. Containing a working elevator, stairs and all the characteristics of a Dutch barn, the building was a wonderful compliment to the evening, and was invaluable in displaying the features Mr. Zoch referred to in his slides.

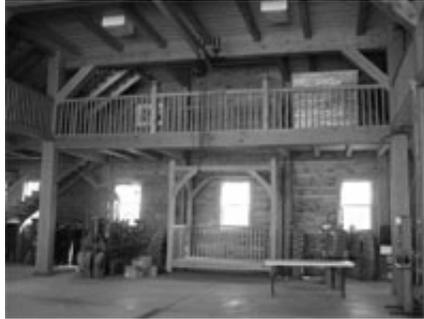
Inside look including the elevator and wide center aisle.

What are some of the characteristics to look for in identifying a Dutch barn? A steeply pitched roof, doors on one end (not on the sides), a wide center aisle inside and narrow side aisles, big supporting columns within, are all indicative of a Dutch barn. The end with the doors will actually have a tall main door in the middle, a split door next to that, and animal doors on each side of the end. The main door will have a small roof over it to keep water off the sill below – again, preventing the rot that would lead to the demise of a barn. Originally, parts of the upper “floor” of the barn would consist of saplings laid side-by-side from one anchor beam to the next on which to lay hay. If the barn held animals, the beams were required to be white-washed. Lumber flooring rested along center beams and was held in place with wood pegs. Normally, Dutch barns were 40-foot-square, although Mr. Zoch remembers one in Middleburgh that was 60-foot-square.

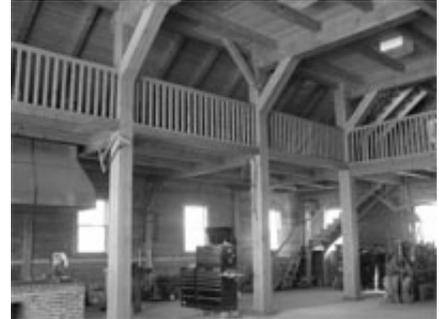
Typical beams and structure joints.

The uprights carry the anchor beam, which have angled supports to help spread the load down to the ground. Where the uprights meet the ground, David had drilled a vertical hole in the bottom center of each upright to house a pipe coming up from the ground. A peg was then inserted horizontally through the bottom of the upright and pipe to secure them.

Dutch barns survive for two reasons: first, they are built “off the ground” on columns of field stone to encourage air circulation below the building which prevents rot; second, eighty-percent of the roof load is on the beams and not the sides, so they tend not to collapse. Examples of Dutch barns can be found throughout Schoharie County, although they are fast disappearing as they are being purchased, dismantled and moved out of state. Harold estimates that eighty-percent of the Dutch barns that were in the county 40 years ago are gone. The John Bates Family Farm has a Dutch barn. The Lutheran Parsonage in Schoharie, built in 1743, is a good example of a Dutch barn. It was moved 1 house length and during restoration the typical mud and straw-filled walls could be seen as well as the roman numerals used to identify the two pieces of a structure joint. One of his slides showed quite clearly how small pieces of sapling were used to hold the mud and straw in place.
